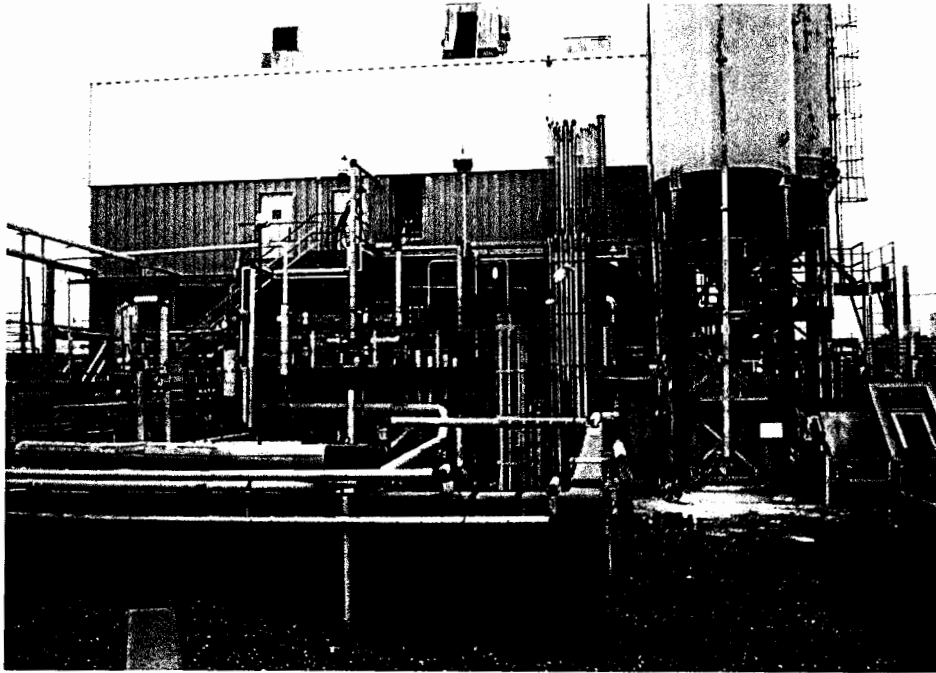
7.1 Tank No. 51 Mix Tank; Tank No. 52 Contact Tank; Tank
8.1 No. 56 Filtrate Tank; Tank No. 50 Lime Slurry Tank; and
12.1 Tank No. 55 Hot Water Wash Tank. View facing west. SWMUs
13.1 7, 8, 12, 13, and 15 are visible in the photograph beneath
15.1 the yellow walkway adjacent to the Solid Waste Facility
filter building.

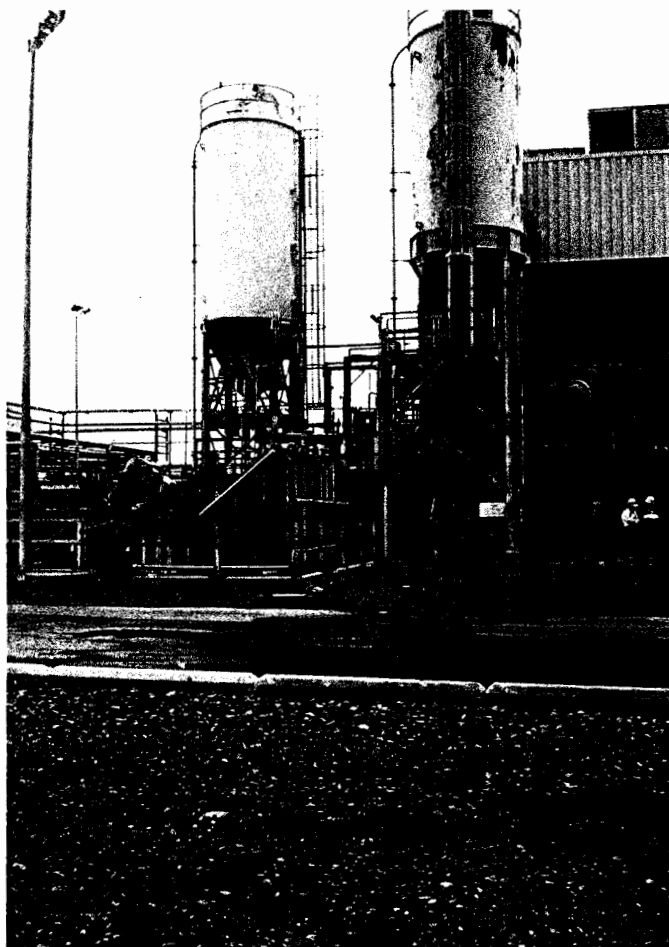
17.1 Catalyst Fines Silo. View facing south. The tank on the right is SWMU 17 and the tank to the left is the Lime Silo.

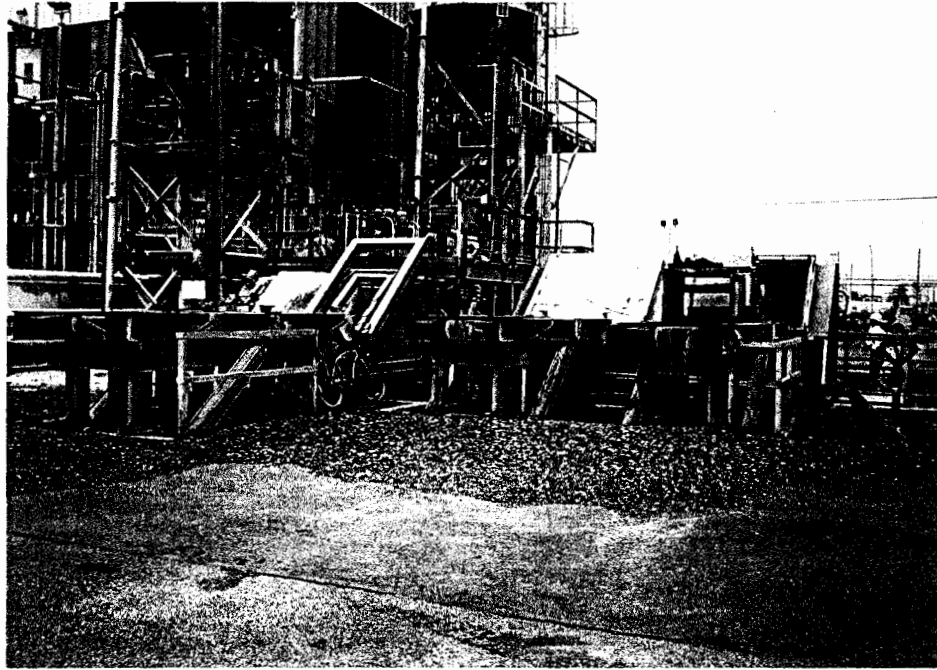
18.1 Lime, Spent Clay, and Catalyst Loading System. View facing west. The unit, which is no longer in use, is the large blue metal structure in the concrete sump area.

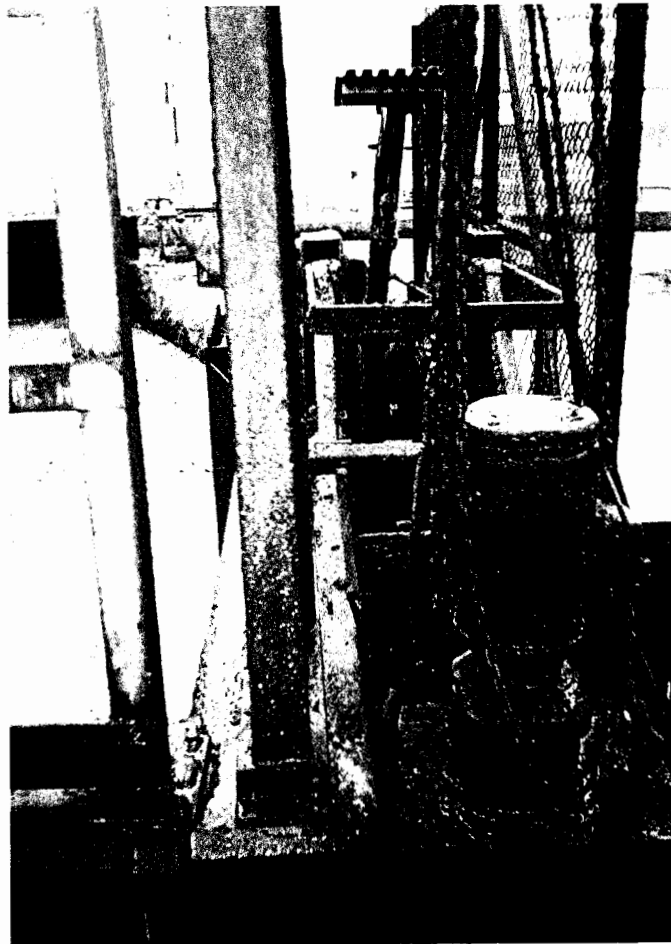
19.3 Sludge Receiving Trough. Close-up view facing south of the comminutor for SWMU 19. The comminutor filters out large debris from the sludge.

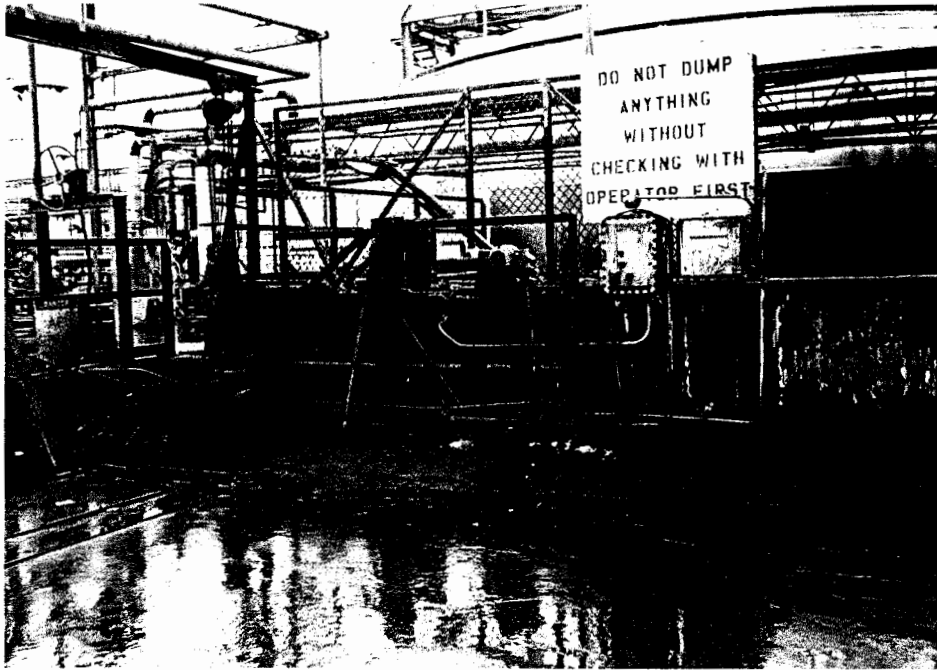
19.6 Sludge Receiving Trough. Exterior view facing east showing the outside of the western wall of the trough and the pad to the west of the trough shown in Photograph 19.5. The receiving trough is behind the fenced wall. The comminutor is to the left of the electric boxes. The pad in the foreground is part of the truck unloading area.

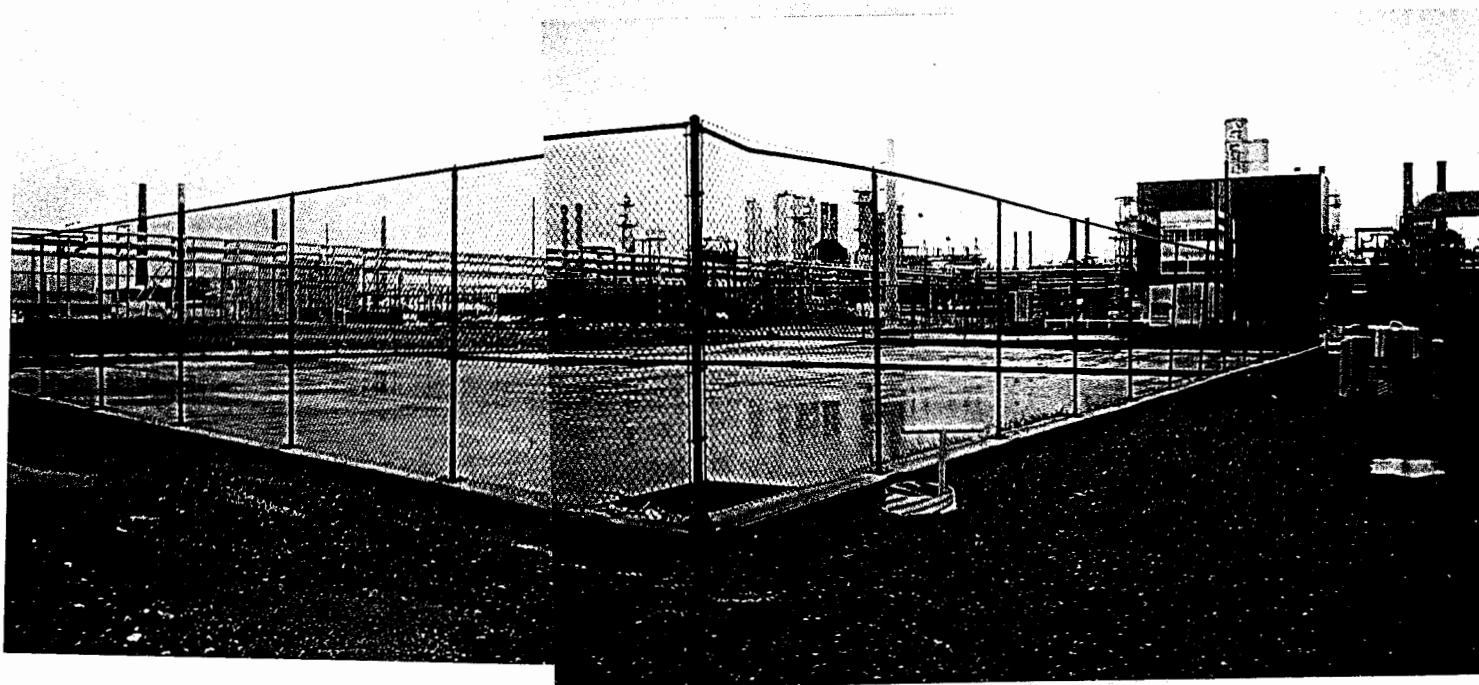
22.1 Hazardous Waste Container Storage Pad. View facing northwest. Dry sump in the foreground collects runoff and spills from the pad. The release valve for the sump is painted yellow. Water is routed to the DELCORA POTW.

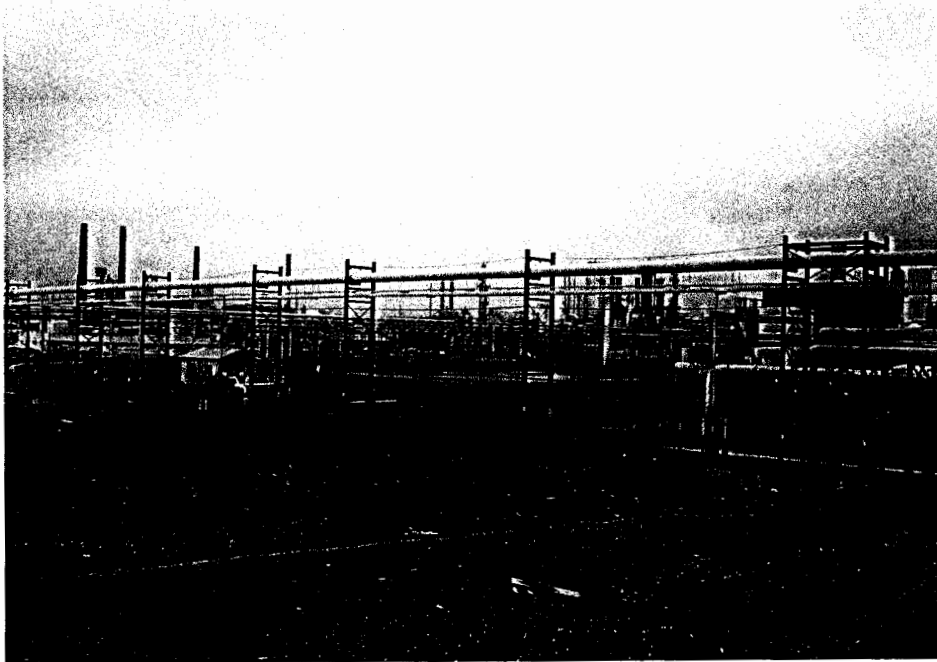
- 23.1 Old Sludge Basin and Old Decant Basin. An overview facing
 24.1 northwest toward the facility shows the 15 Oil/Water
 Separators (SWMU 87-94) (yellow railing in the distance) and
 SWMU 22 (fenced in concrete pad in the distance). The Old
 Sludge Basin (SWMU 23) and the Old Decant Basin (SWMU 24)
 are beneath the Hazardous Waste Container Storage Pad (SWMU
 22).

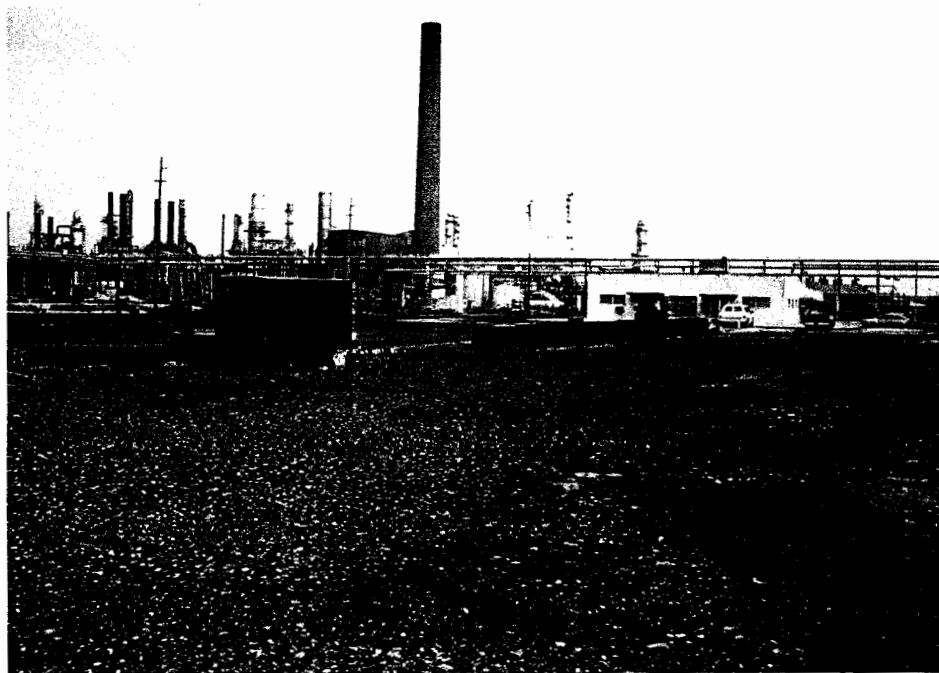
- 23.2 Old Sludge Basin and Old Decant Basin. View facing east
 24.2 of SWMUs 23 and 24. A railroad tie storage area sits on this
 portion of the basin.

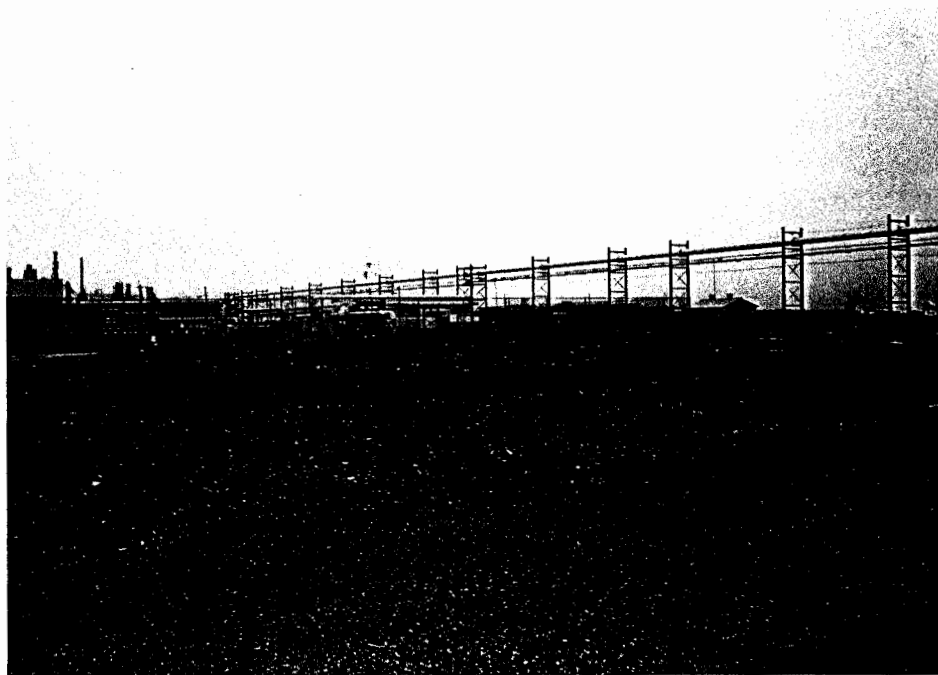
23.3 Old Sludge Basin and Old Decant Basin. View facing east
24.3 of the basin boundary. The Hazardous Waste Container Pad
(SWMU 22) is visible to the far left in the photograph.

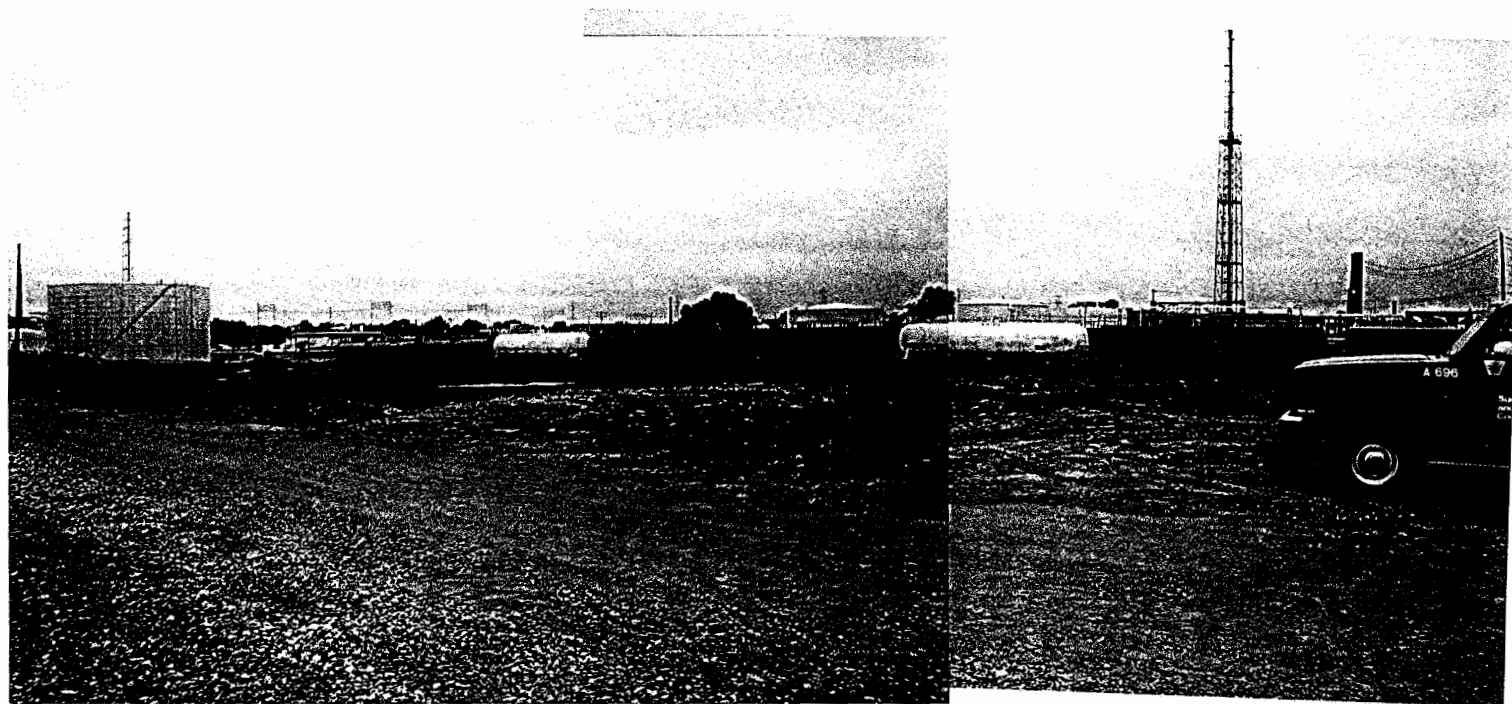
25.1 Old 12 Plant Sludge Basin. Panoramic view facing west to northwest of the basin area.

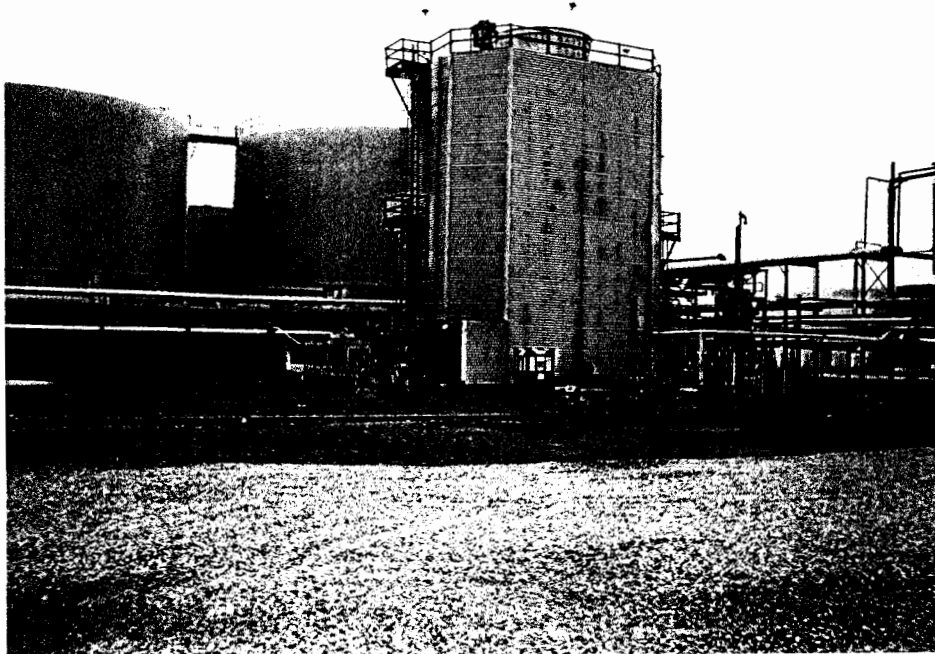
26.1 Old 18 Plant Sludge Basin. View facing west of the basin area which extends underneath the cooling tower in photograph.

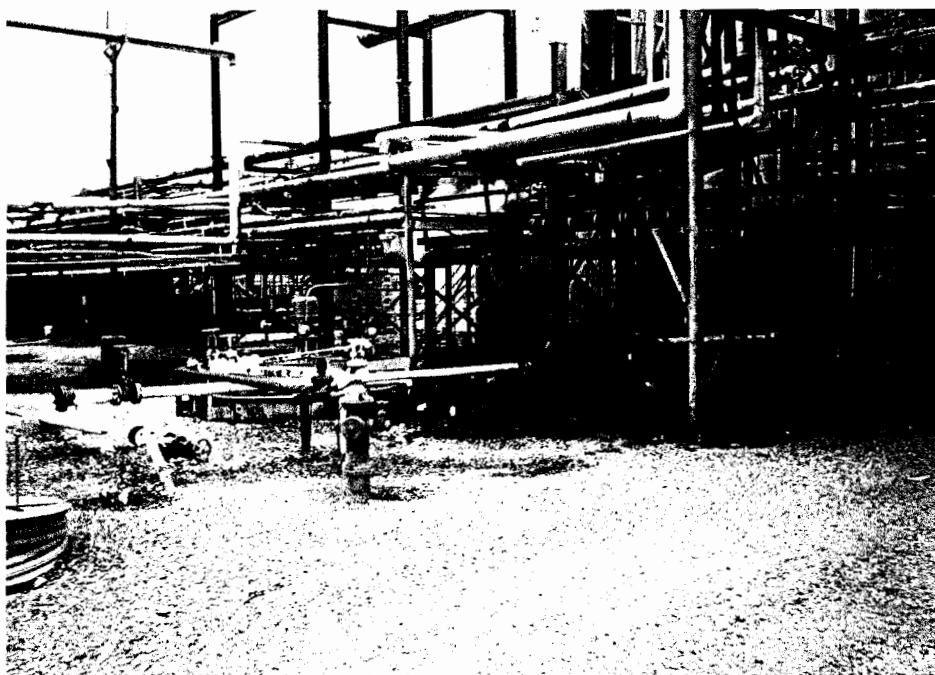
26.2 Old 18 Plant Sludge Basin. View facing south toward old tank at 18 plant in the vicinity of the Old 18 Plant Sludge Basin (SWMU 26).

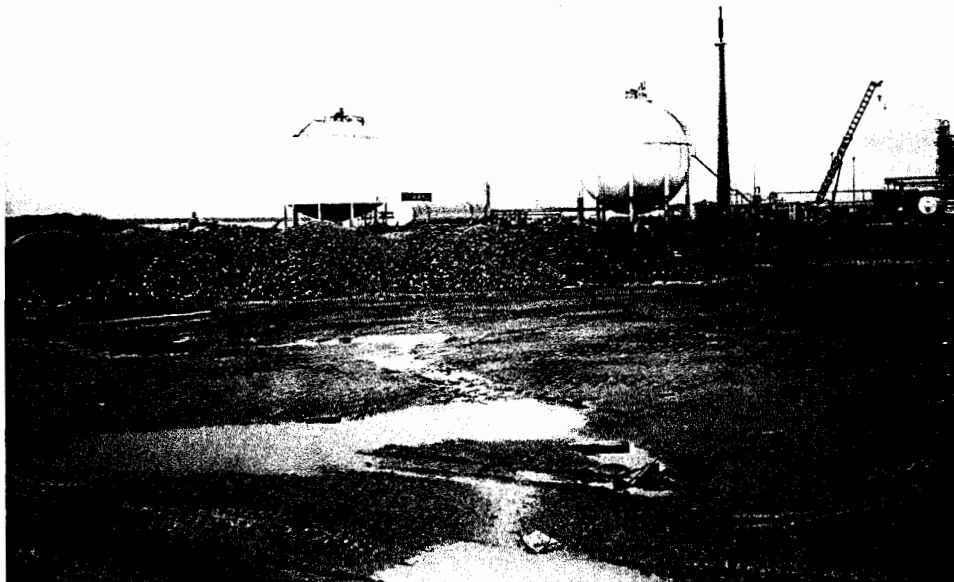
27.1 Phillips Island Area. View facing southeast toward piles of gravel material removed from above-ground containment areas throughout the facility.

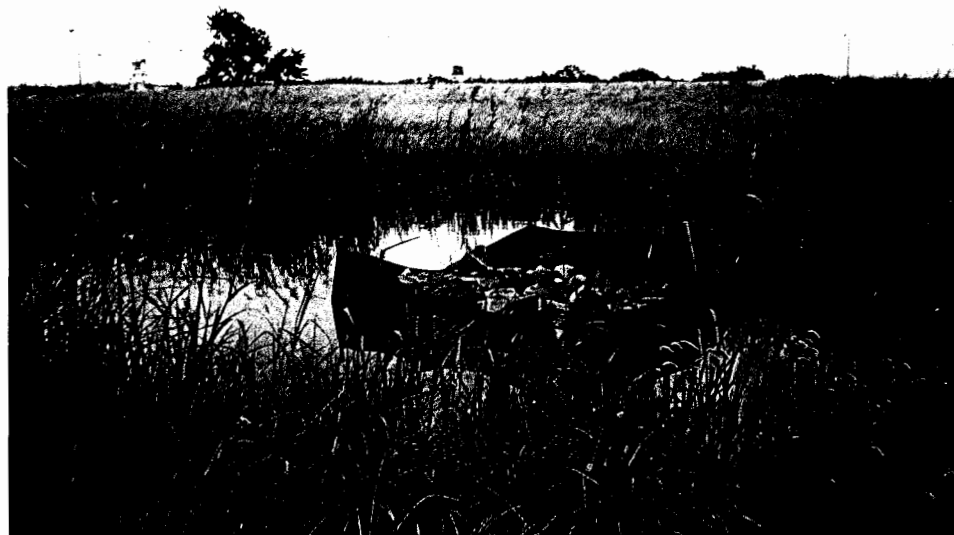
27.2 Phillips Island Area. Close-up view of the water catch basin at the north side of the island. The Combined Process/Storm Sewer System (SWMU 95) receives drainage from the basin.

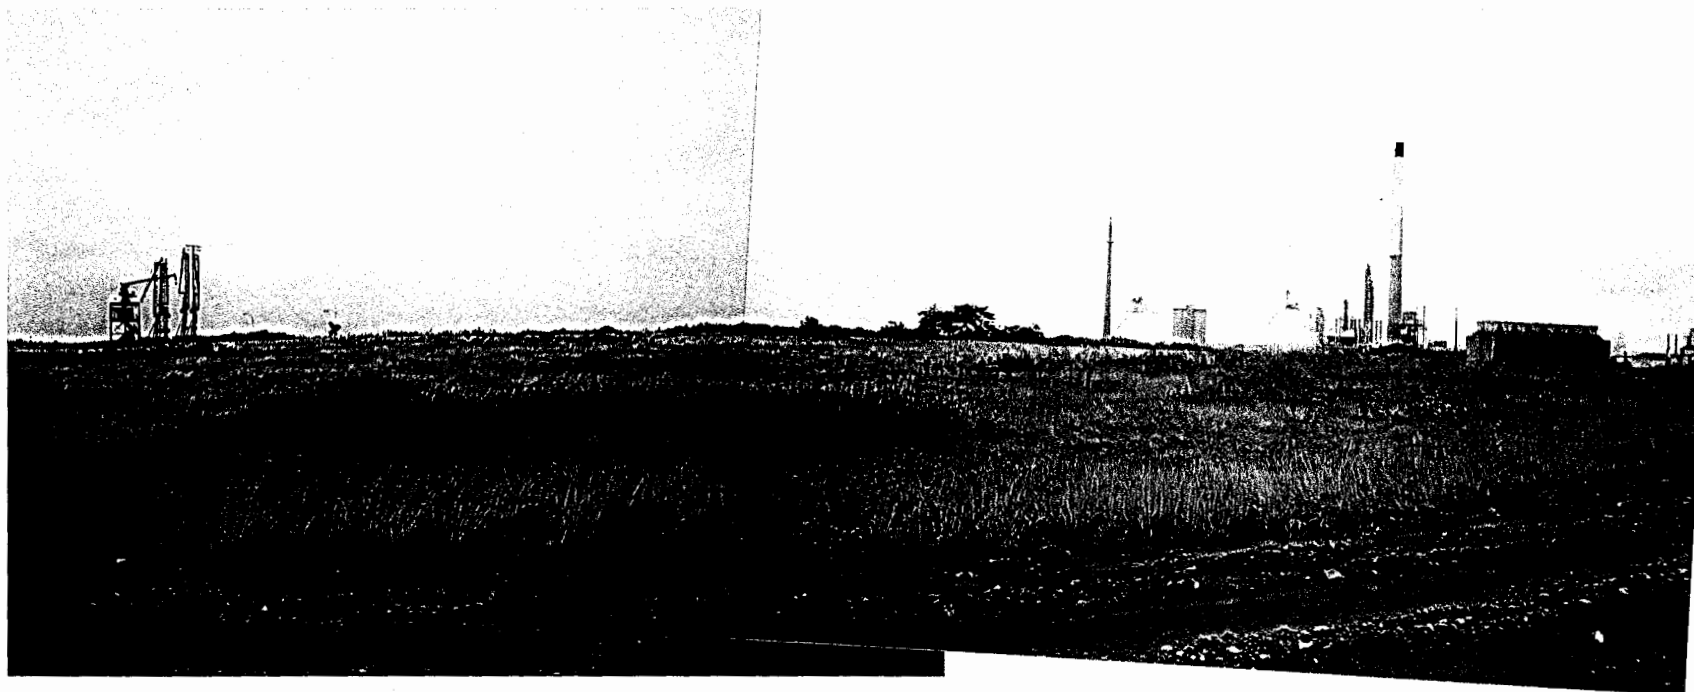
27.3 Phillips Island Area. Panoramic view facing south. Fill and vegetation comprise the majority of the island.

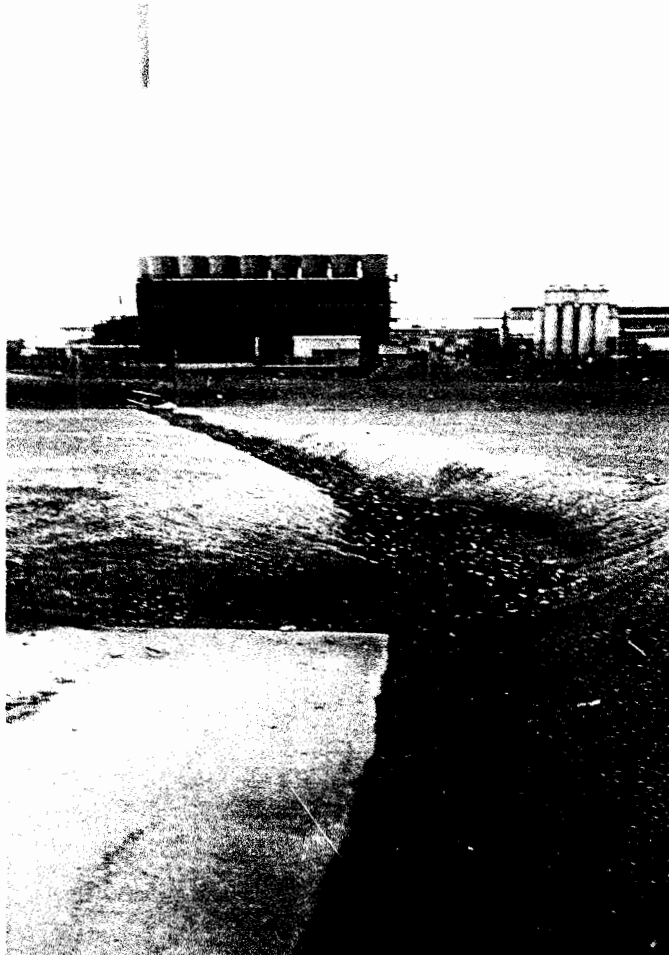
31.3

Fire Fighter Training Area. View facing south of the man-made, unlined drainage ditch originating north of the main exercise pad. The ditch routes discharge from the tanks used in training exercises in the area to the Combined Process/Storm Sewer System (SWMU 95).

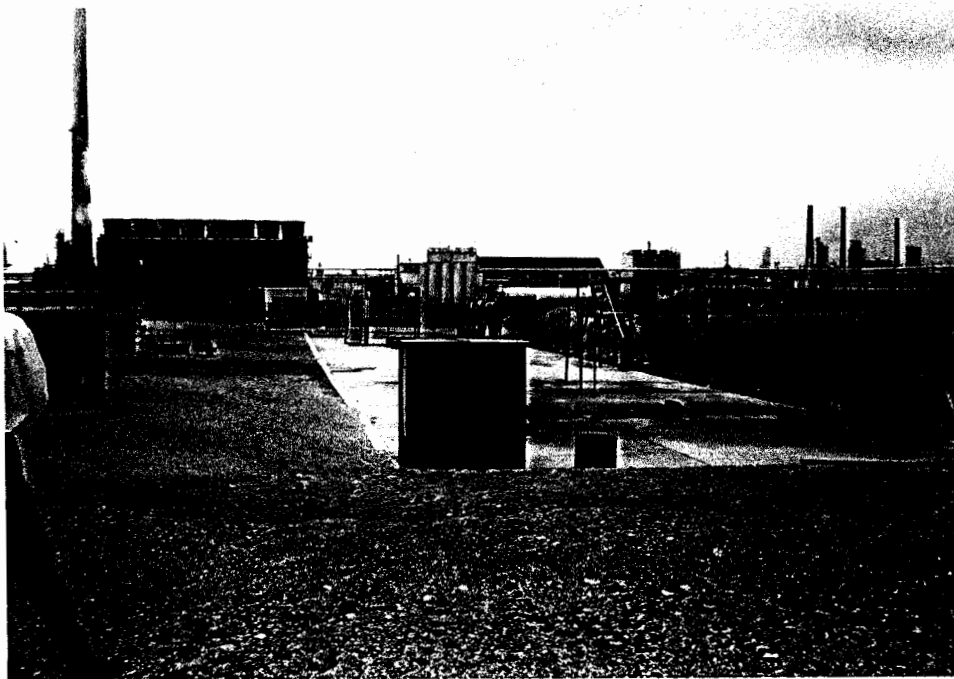
31.2 Fire Fighter Training Area. View facing south toward the main fire fighting exercise pad. The bermed area to the right of the pad is the ground flare area (no longer in use).

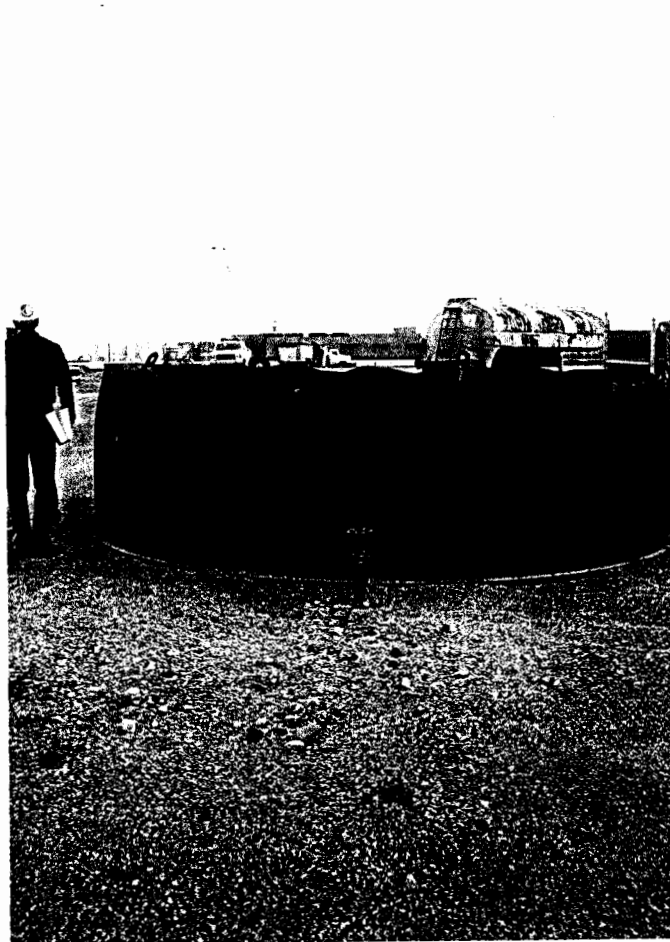
31.4 Fire Fighter Training Area. View facing southwest of the smaller tank used in training exercises. Note the release valve at the bottom of the tank.

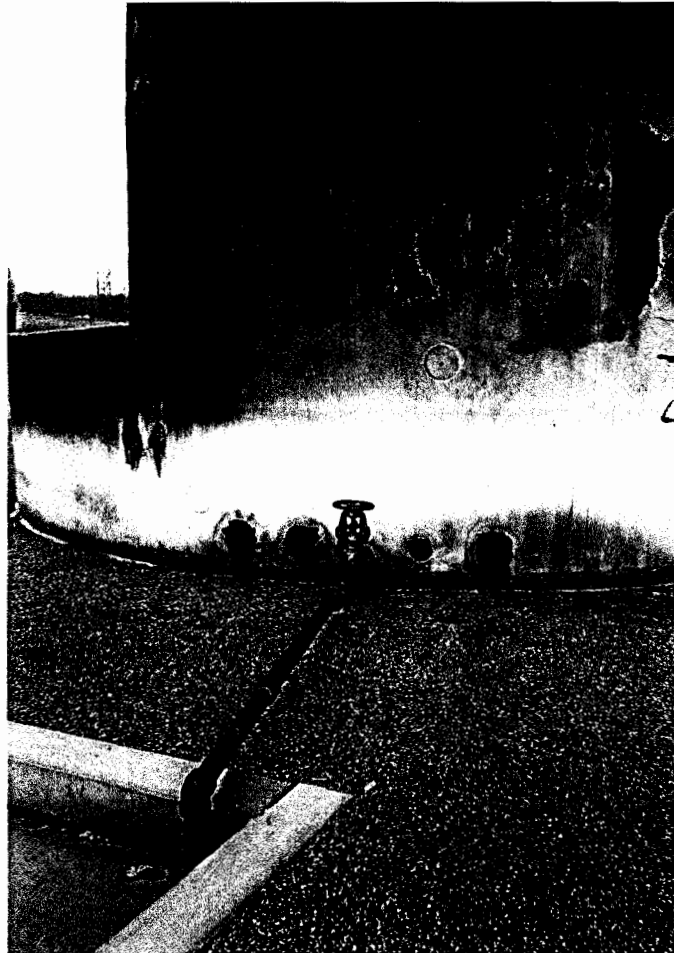
31.5 Fire Fighter Training Area. Close-up view of the release valve for the half cut tank used in training exercises.

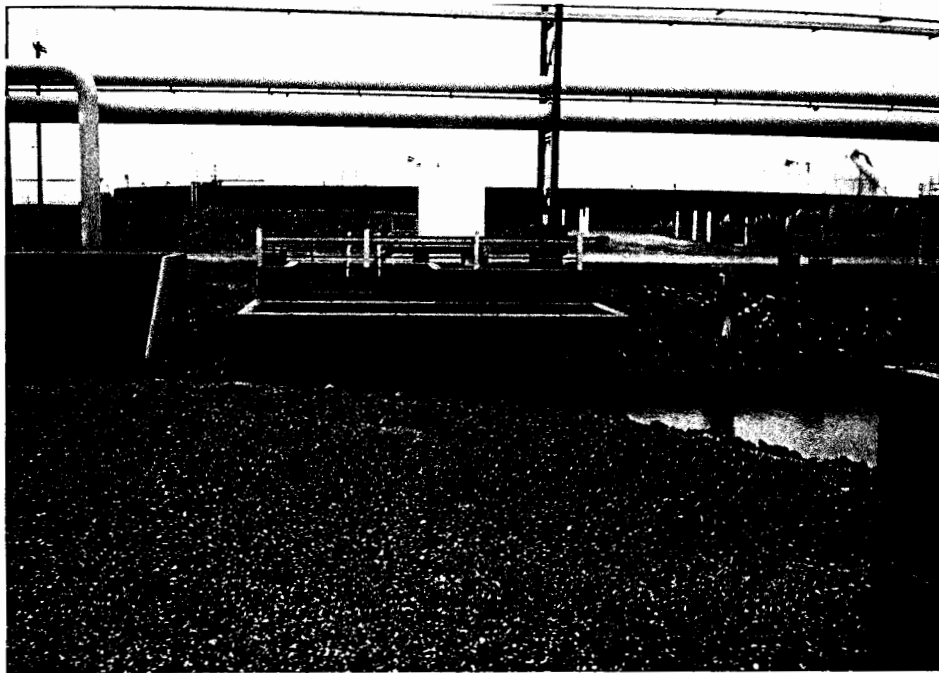
32.1

Impoundment Tank T-101. Exterior ground-level view facing south. The impoundment tank is the large concrete walled structure visible in the background. The concrete box in the Middle Creek Surface Drainage System (SWMU 96), in the center of the photograph, is an old NPDES outfall for non-contact cooling water from the propane warming unit which is no longer in use.

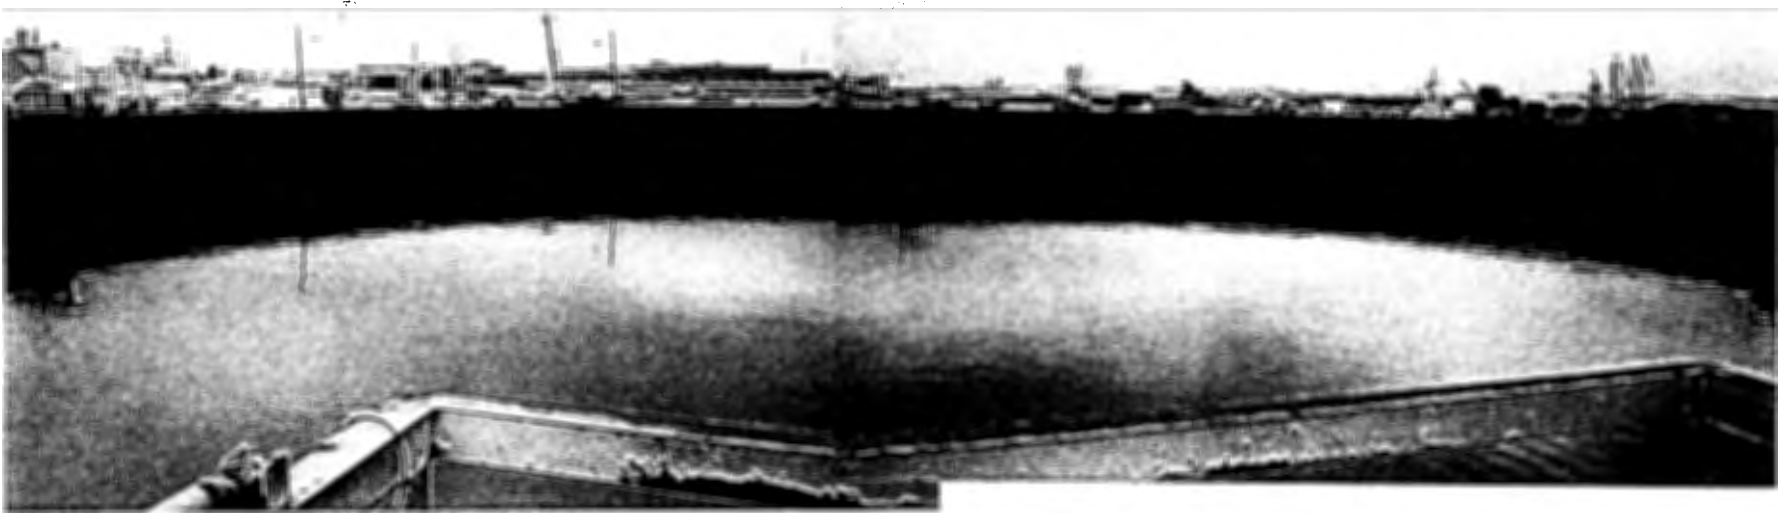
32.2 Impoundment Tank T-101. View facing southwest across the open top of the tank shot from on top of the wall of the tank.

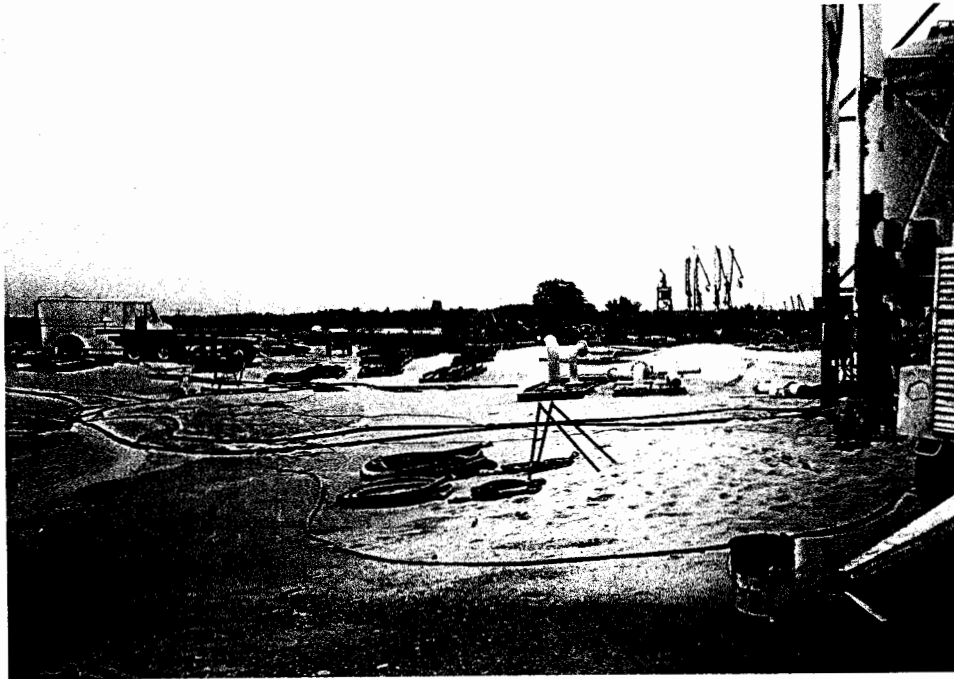
34.1 Phillips Island Sand Blasting Area. Overview facing southeast. Pipes, valves, and metal parts are sandblasted in the area.

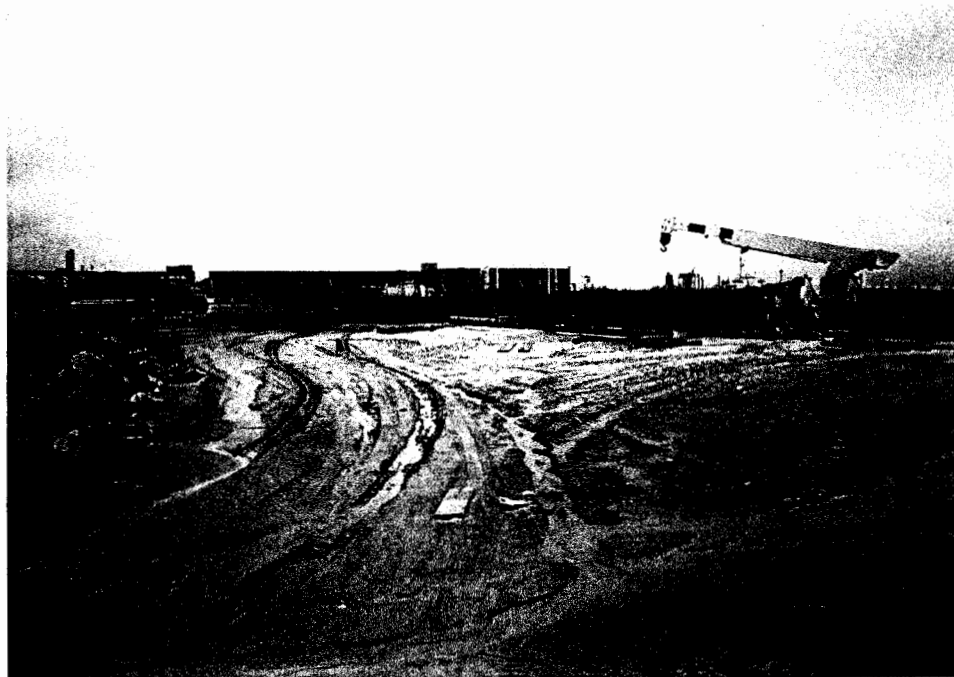
34.2 Phillips Island Sand Blasting Area. View facing north of the Sand Blasting Area.

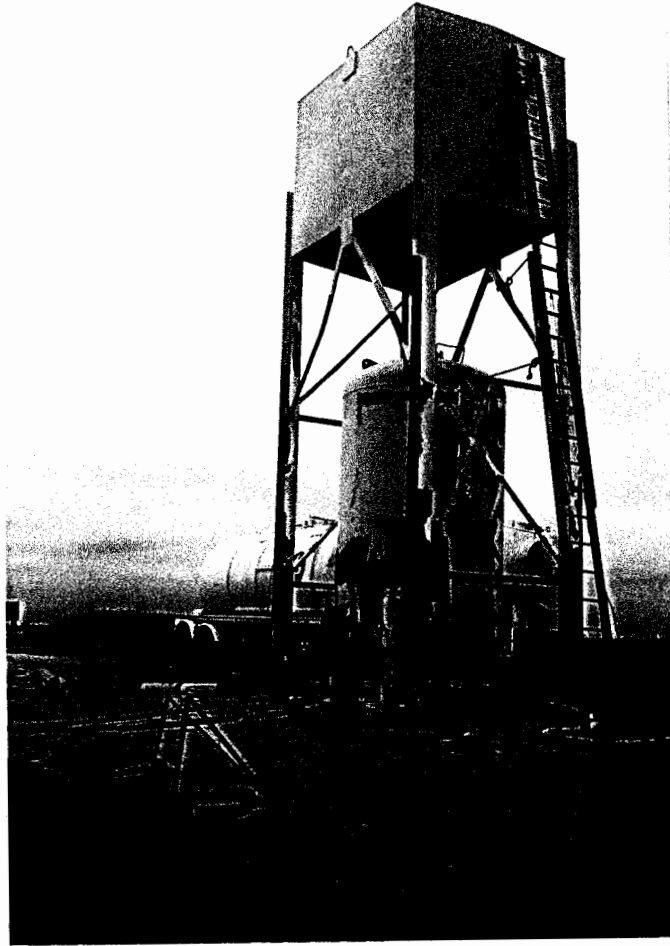
34.3 Phillips Island Sand Blasting Area. View facing southeast
toward the sand storage container. Sand is sprayed through
high pressure hoses.

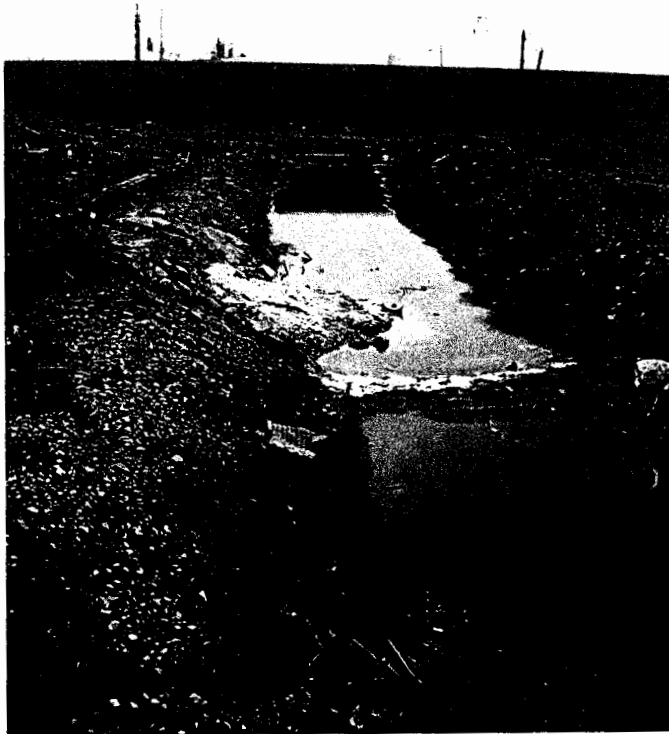
33.1 Phillips Island Surface Drainage Ditches. View facing east of an unlined drainage ditch along the west side of Impoundment Tank T-101 (SWMU 32) and south of the Phillips Island Old Drum Storage/Small Roll-Off Area (SWMU 30).

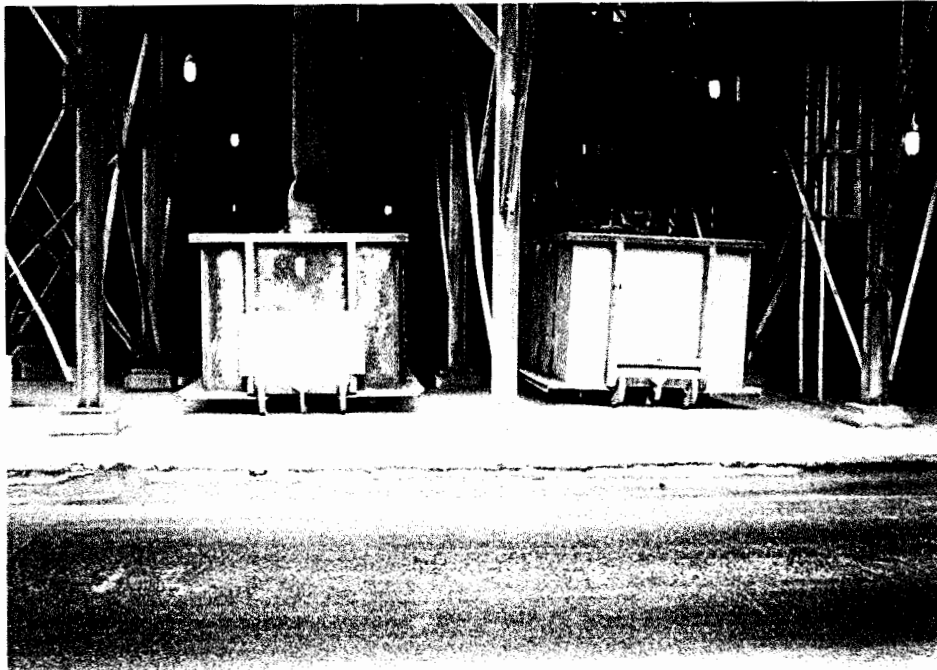
35.1 10-4 Plant Catalyst Fines Collection Roll-Offs. View
36.1 facing north of the catalyst fines loading area at the
37.1 10-4 Plant area. The two roll-off bins shown in the
38.1 photograph are two of the five bins in use in the plant.
39.1

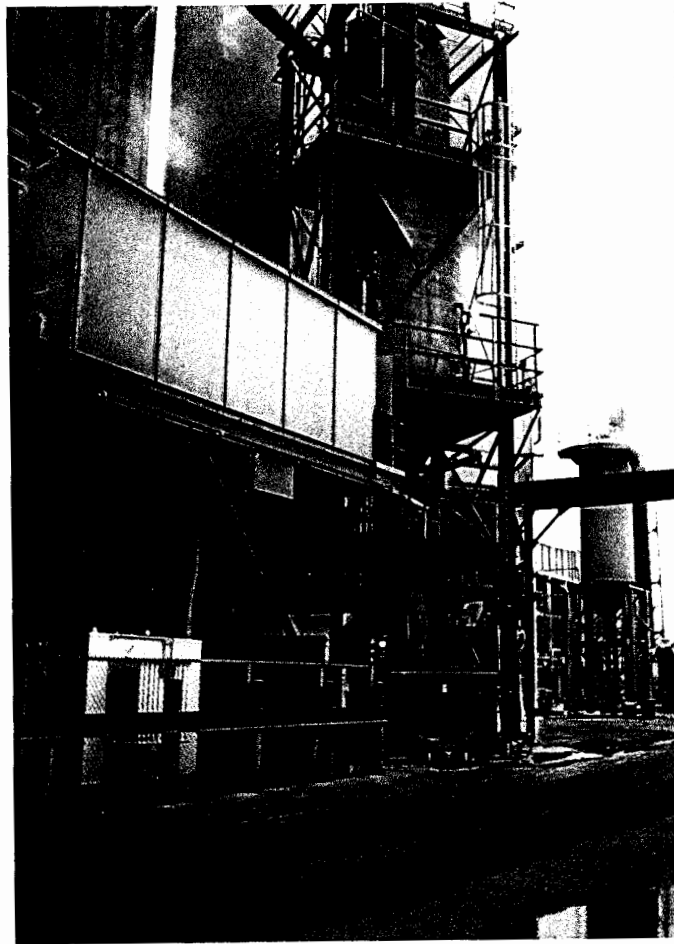
35.2 10-4 Plant Catalyst Fines Collection Roll-Offs. View
36.2 facing north of the catalyst fines collection area for
37.2 fines from the upper portion of the 10-4 Plant. The
38.2 roll-off is green with the Number "22" on the side.
39.2

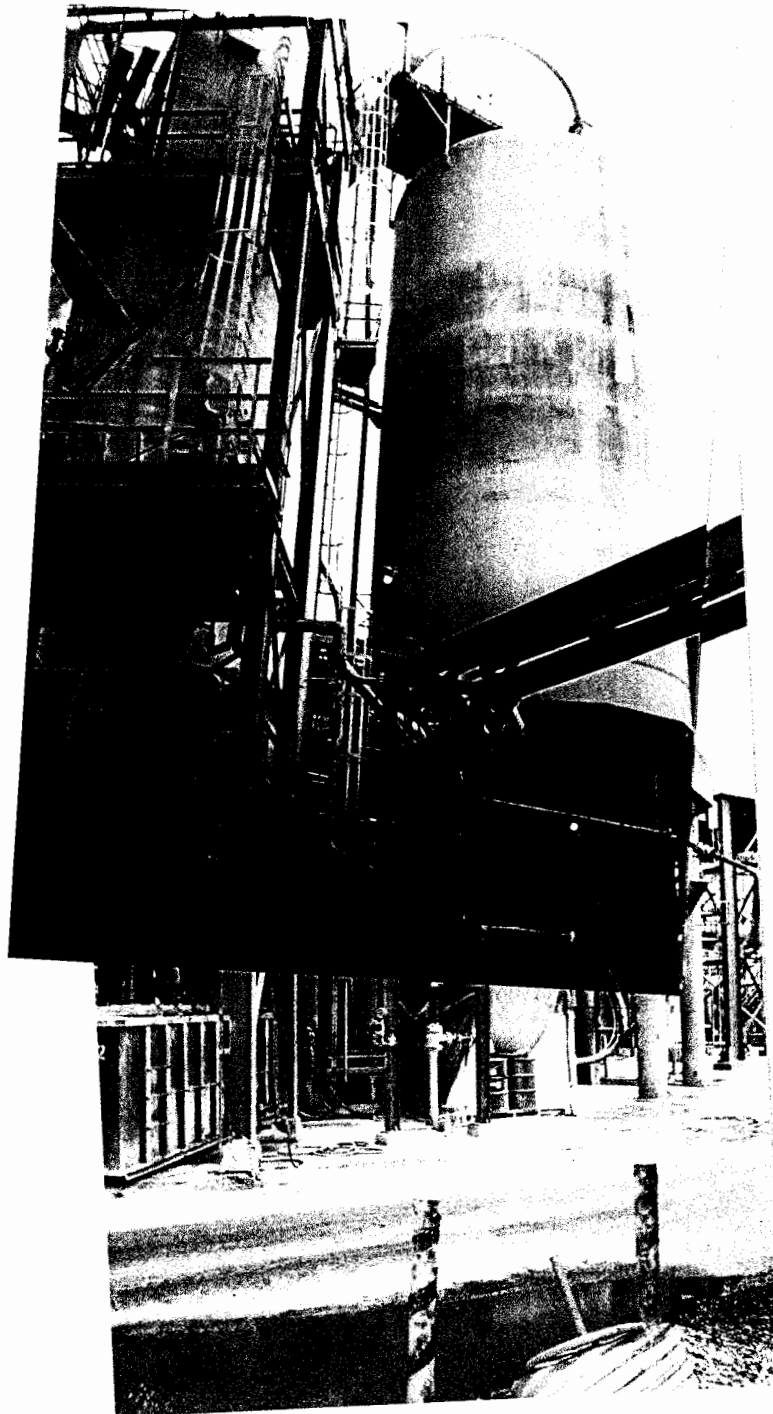
41.1

10-4 Plant Spent Catalyst Silo. View facing north. The unit stores spent catalyst and electrostatic precipitation dust.

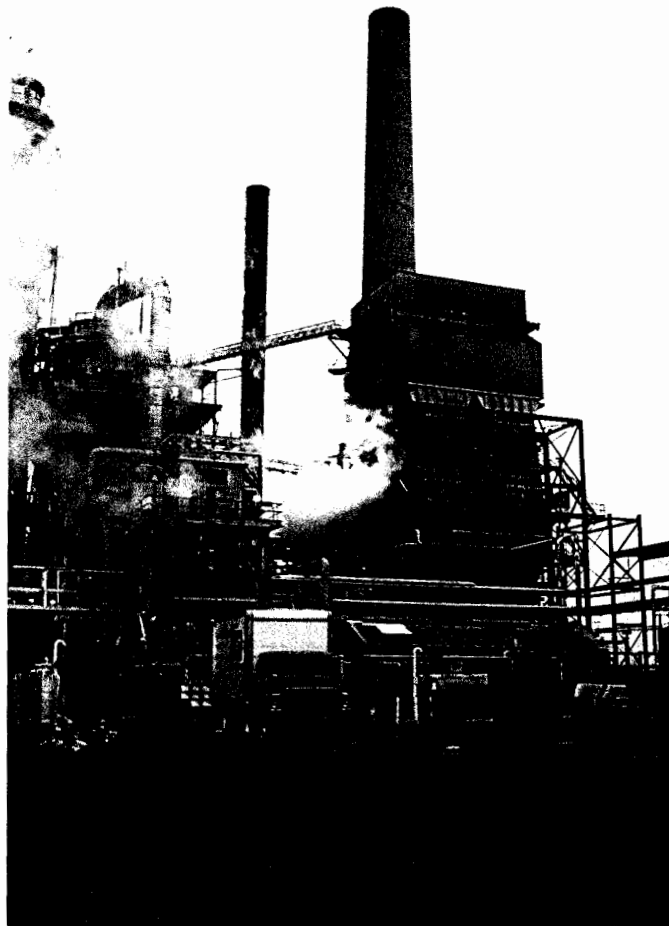
42.1 10-4 Plant Electrostatic Precipitators. View facing east.
The unit is located at the north end of the 10-4 Plant.

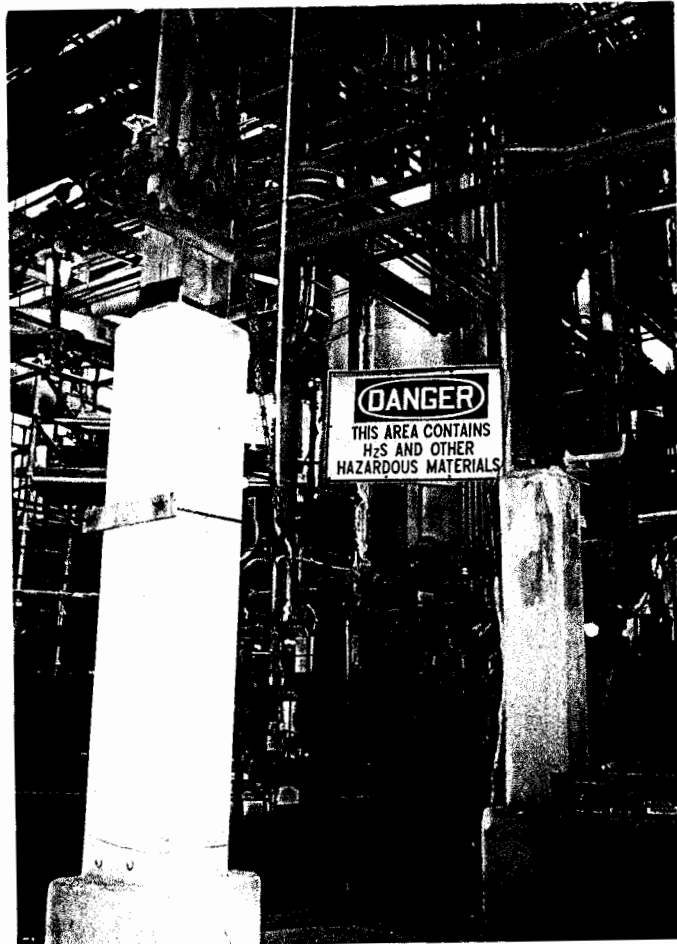
43.1 10-4 Plant Sour Water Stripper. View facing west. The unit is the vertical cylindrical tank in the center of the process area behind the warning sign.

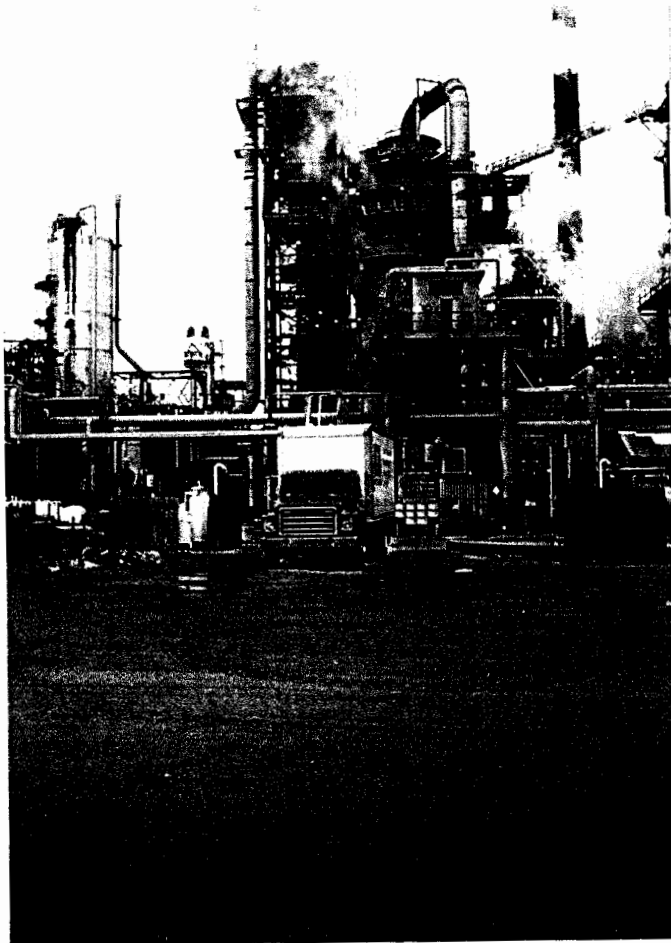
44.1 10-4 Plant Catalyst Regeneration Unit. View facing east.
The unit is a recycling unit for spent catalyst and is the
large cylindrical tank visible in the center of the
photograph.
